From: District of Columbia Office of Disability Rights
Alexis Taylor, Director
Anwar Mahmood, Architect

Re: Accessibility Survey Report:
IN3-At Howard University
2301 Georgia Ave. NW
Suite D
Washington, DC

Date: April 11, 2017

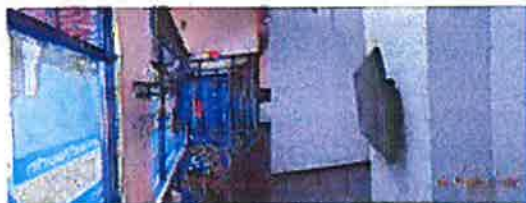
VI. WALL MOUNTED TV MONITORS:

- **ISSUE(S):** Quite a few wall-mounted TV monitors are installed at varying heights and protruding 6 plus inches from the wall. These objects are not detectable by a person with low vision / white cane user (*thereby posing a safety risk*).

SOLUTION(S): The TV monitors need to be reinstalled at locations which do not fall in the path of travel. When possible, placing an object under the television (*ie.* a table, large potted plants, or another item) could temporarily address the problem. Please note the width of the path of travel must still be greater than 32" with the object there. *Please refer to 2010 ADA Standards by DOJ Sections and Subsections 307 and figures 307.2 and 307.3.*

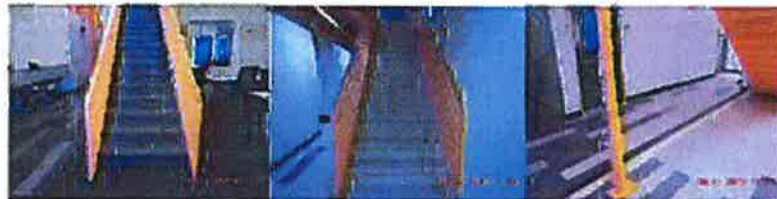
VIII. STAIRCASES

- **ISSUE(S): Yellow Staircases:** Both staircases are not ADA compliant for the following reasons:
 1. The lack of handrail extensions.
 2. The top landing on the front staircase has sloped surface (8.7%).
 3. The underside of both staircases is unprotected and hazardous for a white cane user due to vertical clearance requirements.

SOLUTION(S): *Please refer to 2010 ADA Standards by DOJ Section 307.4, 504 and 505.* For Stairways and handrails modifications.
